## AN INTIMATE FRIEND

» Bowdoin College Preserves Its Art Collection and a Historic Building

# Bowdoin College Museum of Art [ Brunswick, Maine ]

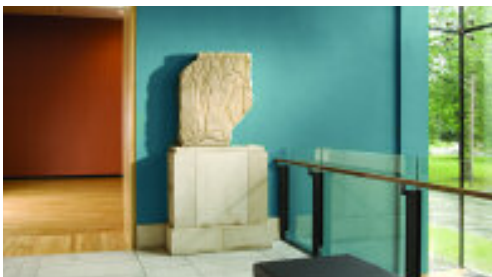
CLERESTORY WINDOWS IN THE BELOW-GRADE AREAS ENSURE THAT EVEN THE SUBTERRANEAN GALLERIES RECEIVE SOME DAYLIGHT.

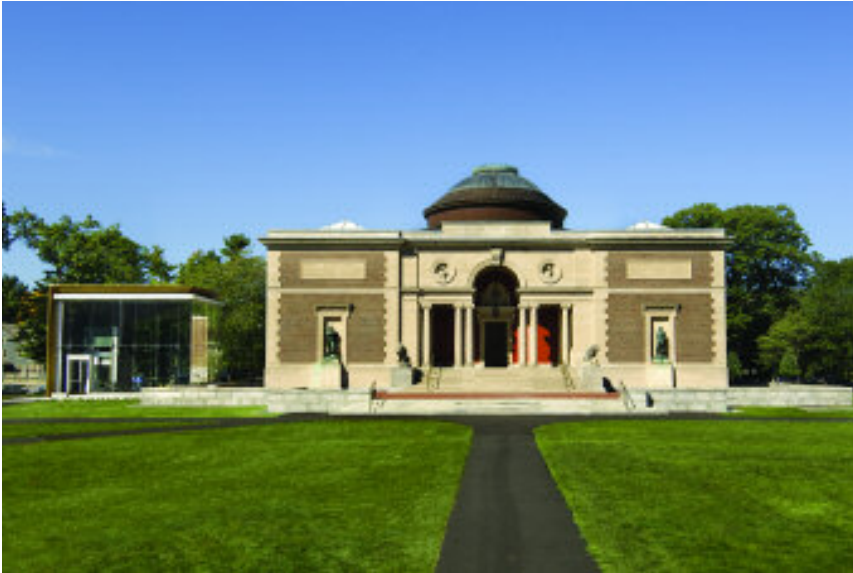
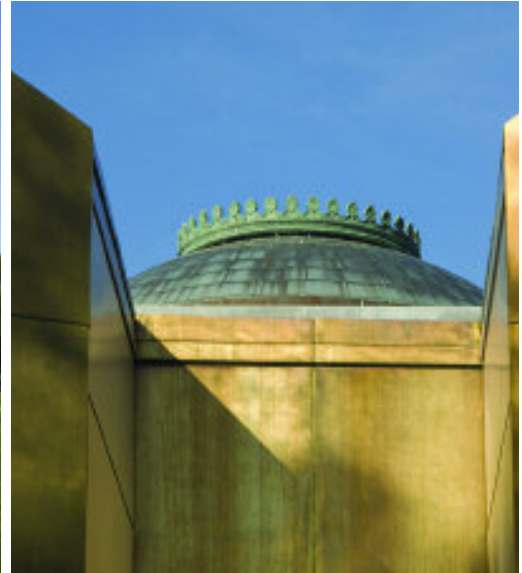
THE GEOTHERMAL SYSTEM CONSISTS OF FOUR, 1,500-FOOT- (452-M-) DEEP STANDING-COLUMN WELLS MATED TO 14, 10-TON (9.1-METRIC TON) HEAT PUMPS. THIS PROVIDES ALL THE COOLING FOR THE BUILDING, AS WELL AS THE REHEAT FOR HUMIDIFICATION.

The geothermal system consists of four, 1,500-foot- (452-m-) deep standing-column wells mated to 14, 10-ton (9.1-metric ton) heat pumps.

This provides all the cooling for the building, as well as the reheat for humidification. “We’re not burning any additional fossil fuels,” Collins adds. “We’ve got no CFC-based refrigerants or anything.”

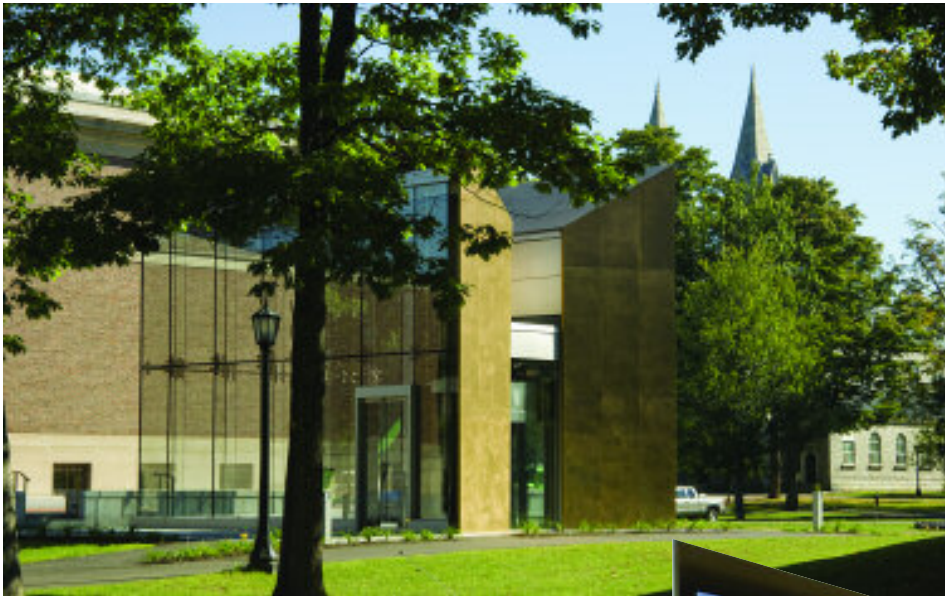
An updated entrance was added to embrace a modern sensibility.

An updated entrance was added to embrace a modern sensibility. "The entrance pavilion is connected underground and physically separated above grade," Ello explains. "It is a 21st-century structure made out of glass and bronze. It's dramatic but small enough to be respectful to the main building. Pairing the new entrance pavilion with the historic building is reflective of the two-sided nature of the collection, which is modern and historic."
